GRADUATE AERONAUTICAL LABORATORIES CALIFORNIA INSTITUTE OF TECHNOLOGY

An Experimental Investigation of the Failure of a Stepped Composite Plate

Thesis by
Steven C. Gortsema

Aeronautical Engineer

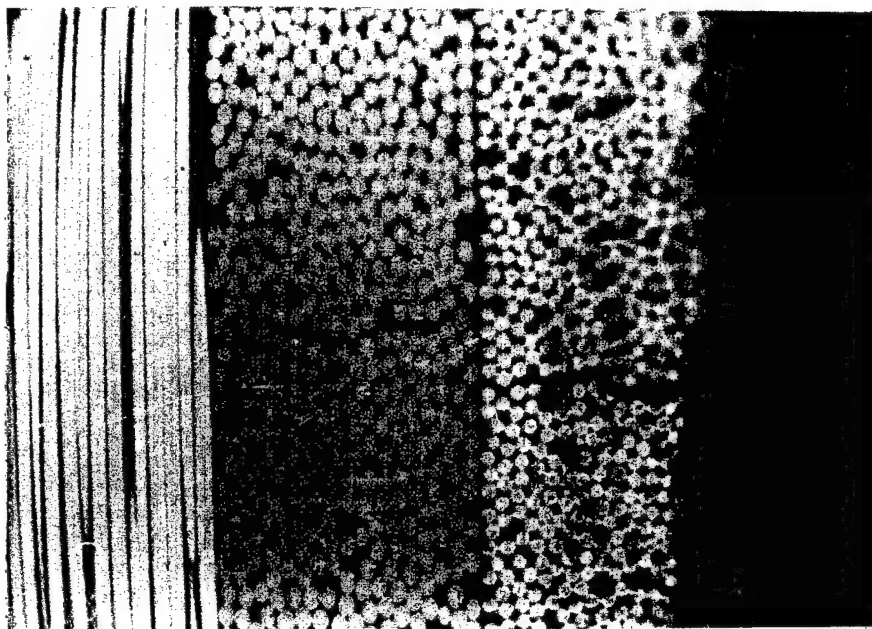
4. $\{M \approx 74\% \text{ of } M_{fp}\}$ Several of the cracks away from the step which had only crossed the 90° ply at the lower loads now propagate across the 45° ply (Figure 10d).

Figure 10d. Crack across the 90° plate interface ply and the 45° ply.

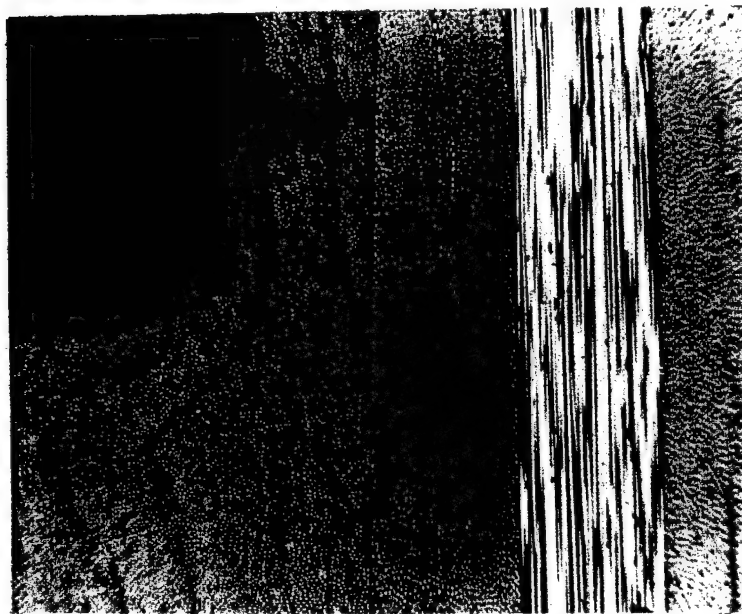
Figure 12d.^{en} Continued delamination propagation.

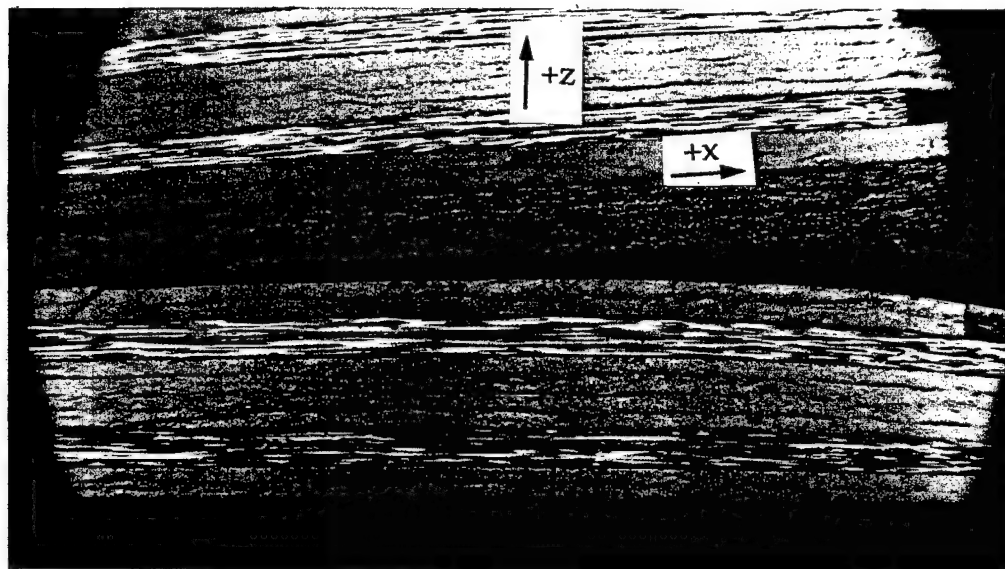
5. $\{M = M_{fn}\}$ Finally, after crossing the 45° ply, the crack with the most negative value of x turns and propagates along the $45/0$ interface. As seen on the positive edge, the area where the crack starts to propagate on this interface usually contains several broken 0° fibers. At this point the crack propagation is usually unstable and leads to catastrophic failure. Again, as noted in the observations on the positive edge, this crack often moves from the interface to within the 0° ply as it runs toward the end of the specimen (Figures 12f and 12g).

Figure 12f. Failed specimen.

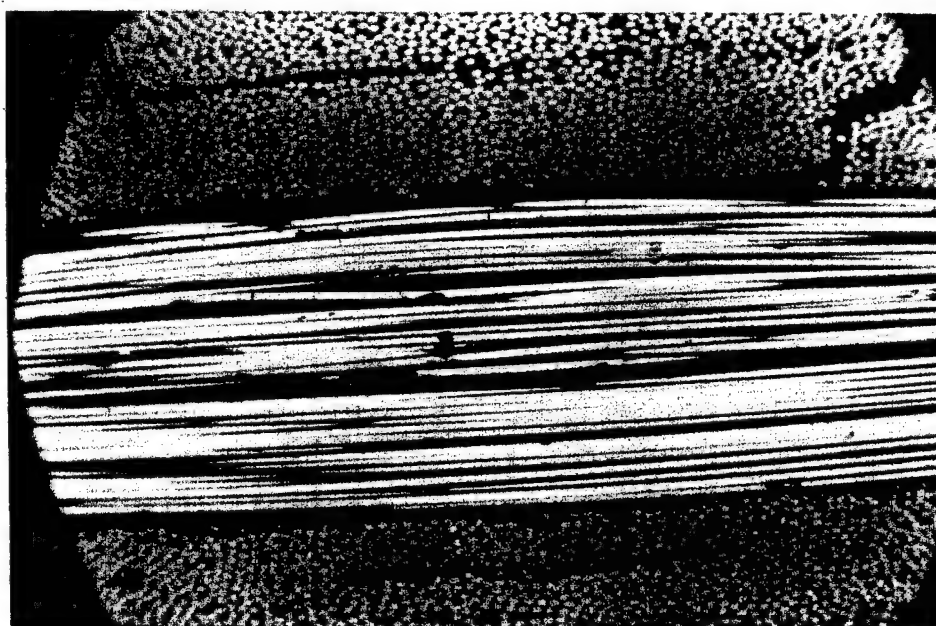
Figure 12g. Close-up of the region near the left of Figure 12f, where 45/0 delamination began.

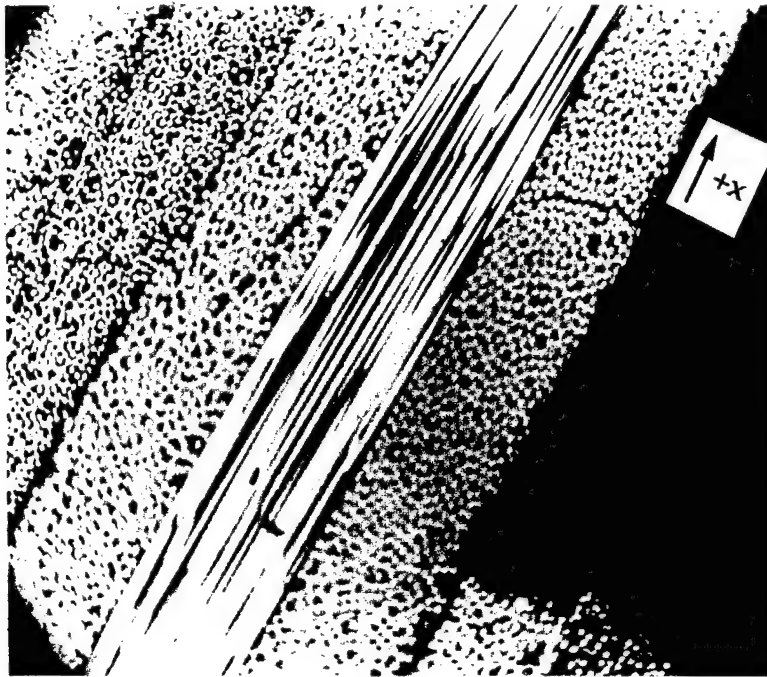
Figure 28a. First crack to appear on the positive edge.

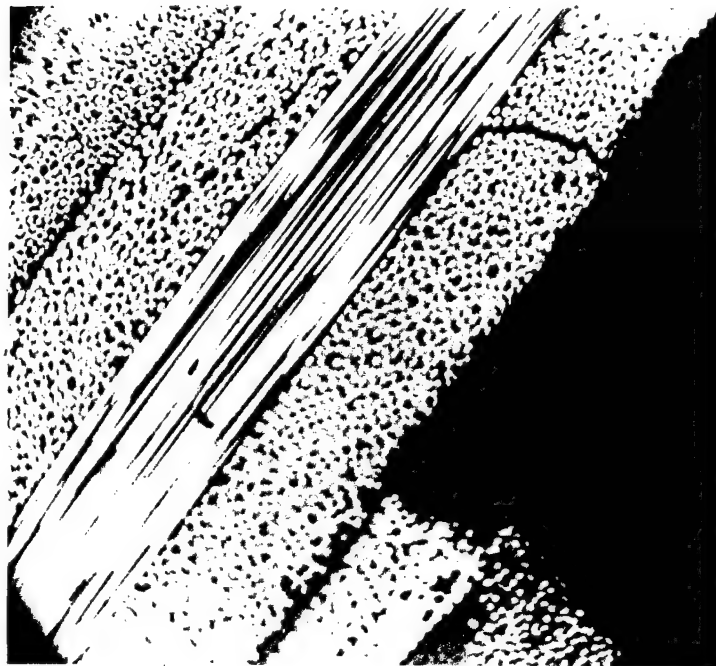
At approximately the same load, 0° fiber fractures are often observed ahead of the 45° ply crack nearest the corner (shown by "2B" in Figure 27). In some cases this crack even turns and begins to propagate stably in the $-x$ direction along the $45/0$ interface (Figure 28b).

Figure 28b. Stable propagation along the 45/0 interface.

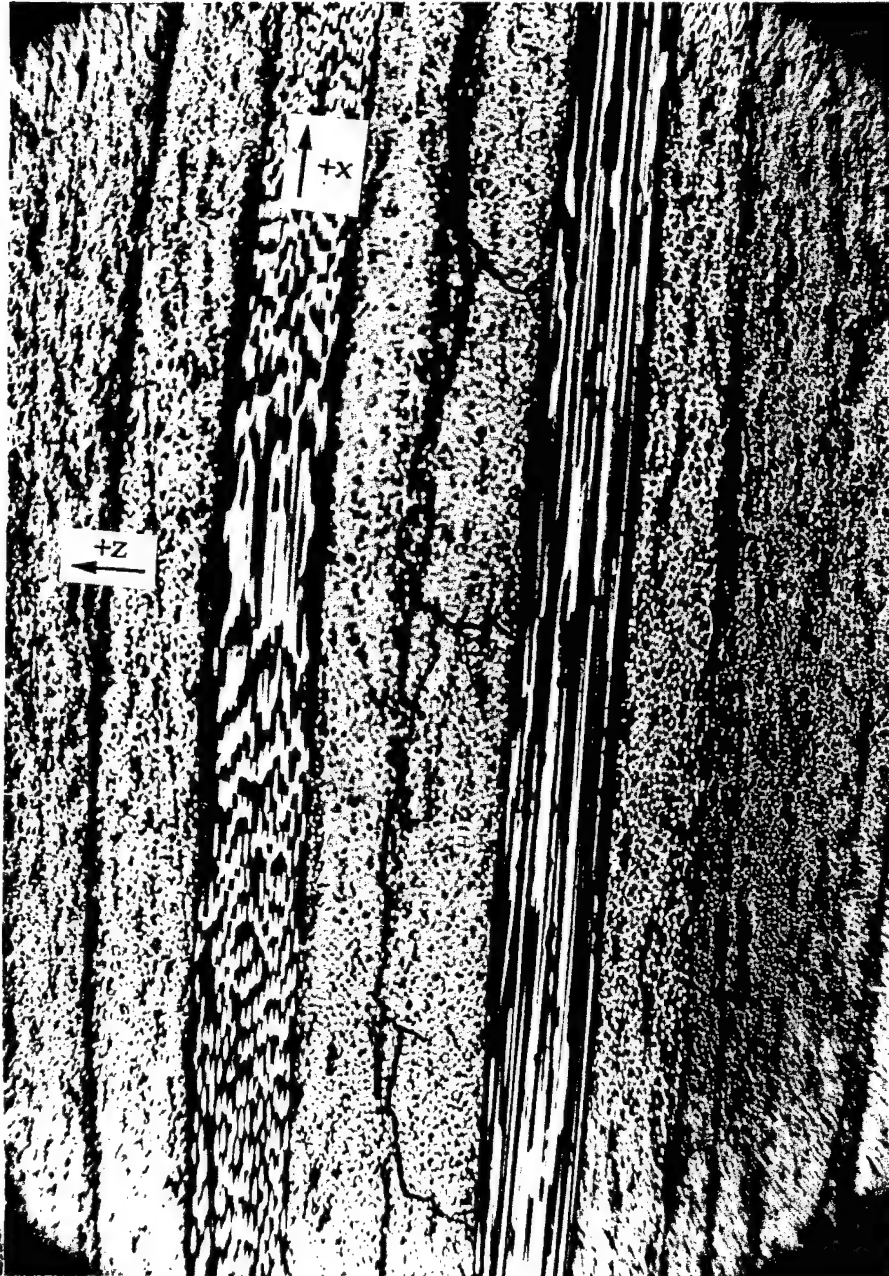
Figure 30.^{en} Delamination propagation on the negative edge.
